# Bartlett Consulting

## TREE SURVEY & CONDITION AND MANAGEMENT REPORT

**OUR REF:** JH/170128/RA/sh

**SITE ADDRESS:** Land Adjacent to Wyebank Road  
Tutshill  
Chepstow  
NP16 7FA

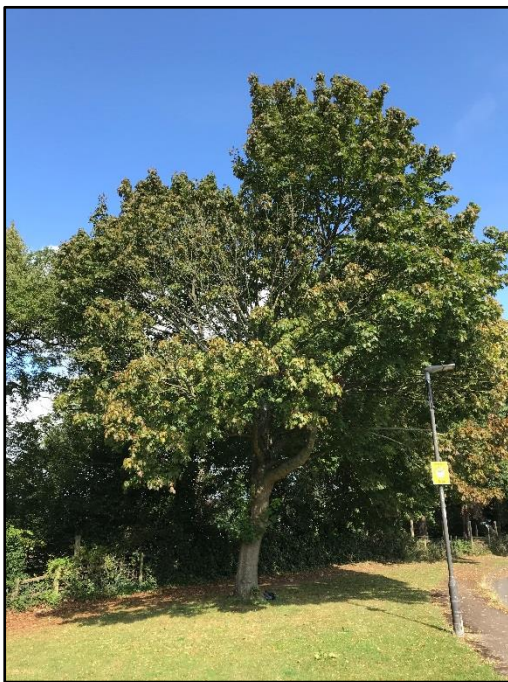
Norway Maple, T264a, is exhibiting significant levels of dieback within the south and west quadrants of the tree crown. The main stem has numerous pruning wounds which have early-stage decay, and the surface roots have evidence of direct damage and decay. These features are considered to be causal factors in the decline in tree health. It may be possible to slow and halt the decline in health through cultural improvements and tree health care practices, to retain the tree. Alternatively, removal and replacement planting is the only other reasonable course of action.

*Figure 3: Image Showing Dieback in West Crown of Norway Maple T264a*

T264a	Open Space	Norway Maple	475	12	7	EM	Low	Moderate: <ul style="list-style-type: none"> <li>Historical direct damage to surface roots.</li> <li>No obvious defects or decay around base of stem.</li> <li>Multiple wounds around stem at 2.0m height from pruning.</li> <li>Sapwood necrosis and early stage decay at all pruning wounds.</li> <li>Busy branch structure typical of species.</li> <li>Well formed unions throughout crown.</li> <li>Major deadwood in canopy.</li> <li>Extensive dieback south and west canopy.</li> </ul>	<ul style="list-style-type: none"> <li>Crown Clean</li> <li>Tree Health Care</li> </ul> (if retention desirable)	Six months	Moderate	C2	Three years

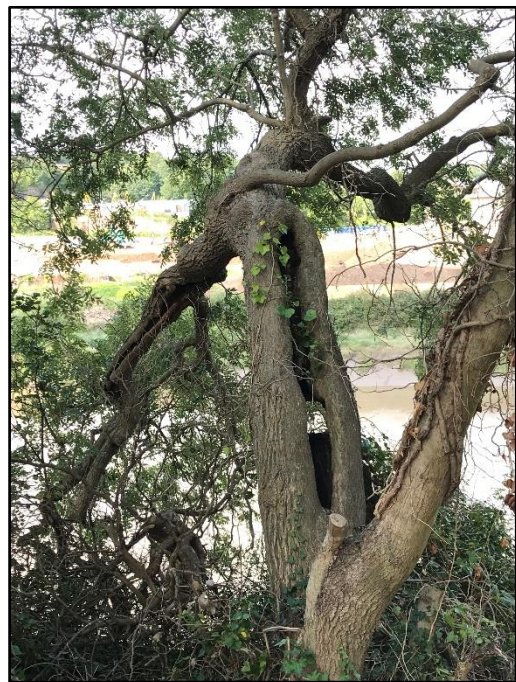
Three Ash trees, G270a and T269a are all in either 'moderate' or 'poor' condition due to early and advanced stage decay of stems and branches. These trees are also exhibiting signs of dieback in the upper canopy. All of these trees are also growing along the cliff face above the River Wye, with some of the stems at an angle over the edge. Ideally these trees should be removed to prevent them falling into the Wye; however, the logistics and safety of this operation cannot be understood without the input of other Arborists.

*Figure 4: Image Showing Advanced Decay and Hollowing in Stem of Ash G270a*

G270a	Cliff Edge	Common Ash	400*	10.5	11	EM	Low	Poor: <ul style="list-style-type: none"> <li>▪ Group x2 trees.</li> <li>▪ No access for full VTA.</li> <li>▪ Both stems w/extensive decay and hollowing.</li> <li>▪ Desiccated fungal fruiting bodies on ground.</li> <li>▪ Both trees with lean towards west.</li> <li>▪ South tree exhibiting dieback.</li> <li>▪ Failure into river.</li> </ul>	To Be Determined	N/A	Moderate	C2	N/A
